LEVEL 2

# Your survey report

Inspection date

01 September, 2021

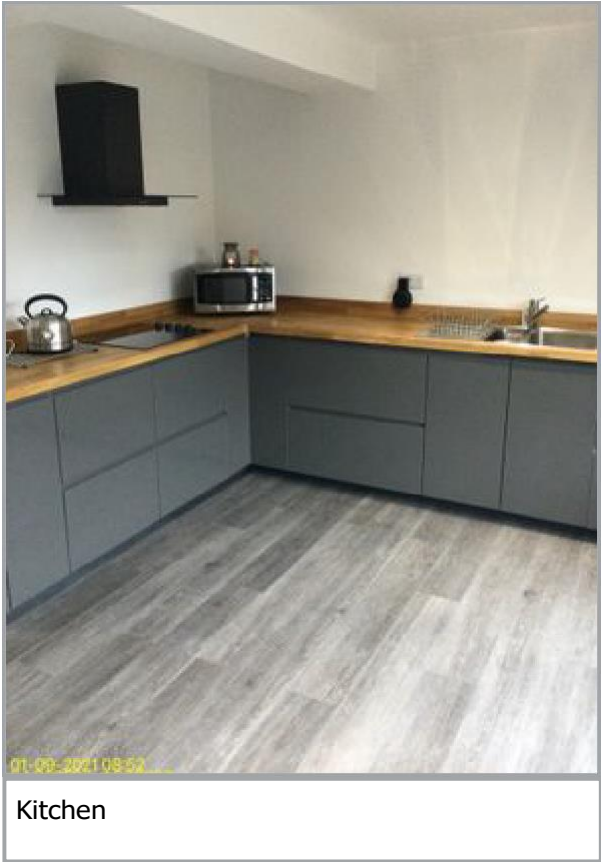
## E7 Woodwork (e.g. staircase and joinery)

The property has timber doors, stairs and skirting boards.

The woodwork is generally in satisfactory condition. The internal decorations are also in fair order. Woodwork requires regular maintenance and decoration.

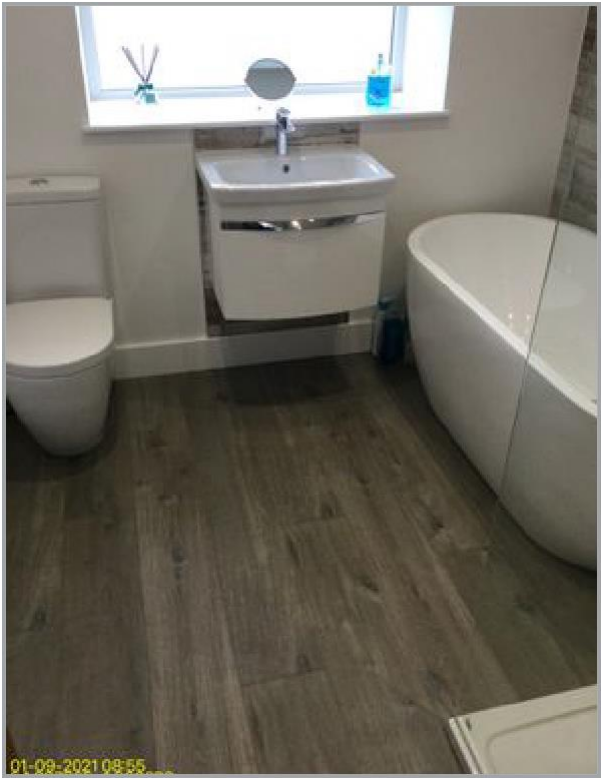
Bathroom

| <p>There are a range of modern bathroom fittings in this property.</p> <p>The fittings are generally in satisfactory condition. We have not carried out any tests on the fittings and therefore we cannot comment on their operation or serviceability. No immediate repairs are needed. Such fittings require regular servicing to remain in working order.</p> <p>A mechanical extractor fan should be installed in the bathroom as there is insufficient open ventilation to remove excessive water vapour.</p> <p>Condition Rating 1</p> | 1 |
