LEVEL 3

# Your survey report

Inspection date  
8th December 2021

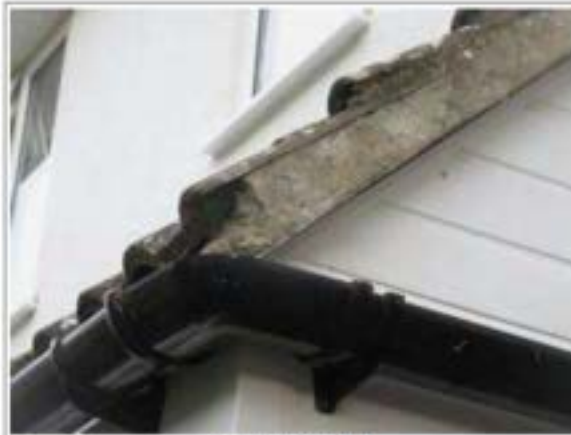
The roof was generally noted to be reasonable condition although some of the bedding mortar to the front of the verge is missing (see photo). This is considered to be slight and no immediate repairs are considered necessary. However, it is recommended that defective and damaged mortar is replaced, as part of routine maintenance.

Missing bedding

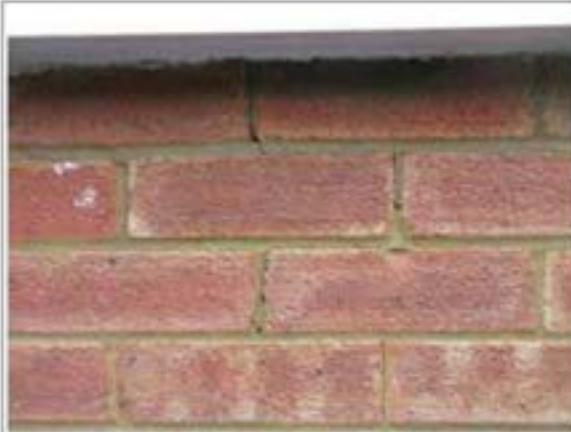
Slight cracking was noted through the brickwork mortar jointing beneath the front reception room window and also through the render beneath the windows of the front left-hand and front middle bedrooms.

The degree of cracking noted is not considered to be of structural significance and did not give cause for concern. It is likely to be due to normal shrinkage that can be expected in properties of this age and type.

Minor cacking

Ideally, cracked mortar joints should be raked out and repointed in order to keep water out.

Cracks to render should be filled with an exterior grade filler, prior to redecoration.

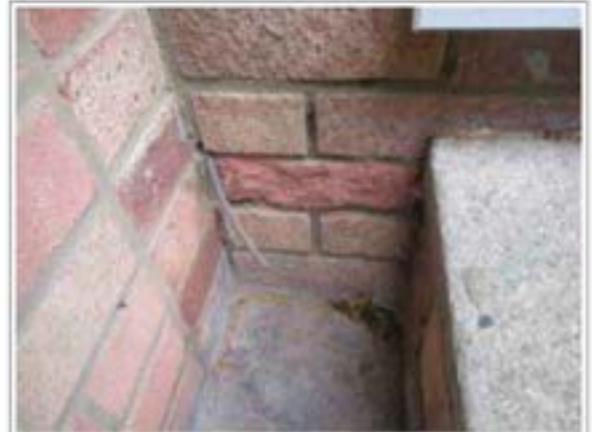
Some erosion was noted to the brickwork mortar jointing beneath the damp-proof course on the right-hand wall and at the front of the extension near to the side entrance door. Loose and missing mortar joints should be raked out and repointed in order to keep water out.

Eroded pointing

The repairs required are not considered to be serious or urgent but should be carried out as part of routine maintenance.

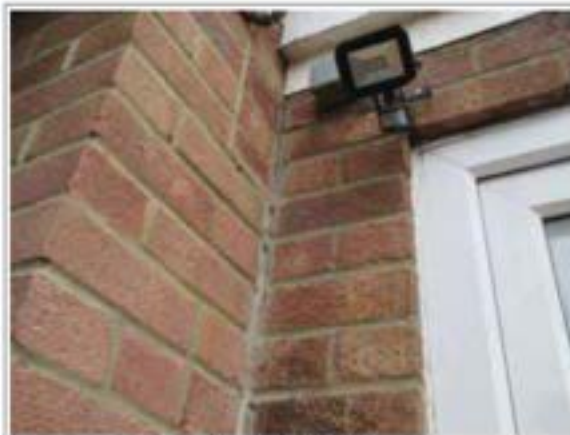
There is slight cracking at the junction of the rear extension and main house wall. This is likely to be the result of initial settlement. The extent of cracking noted is not considered to be of structural significance. The cracked mortar should be raked out and repointed as part of routine maintenance.

Crack at junction

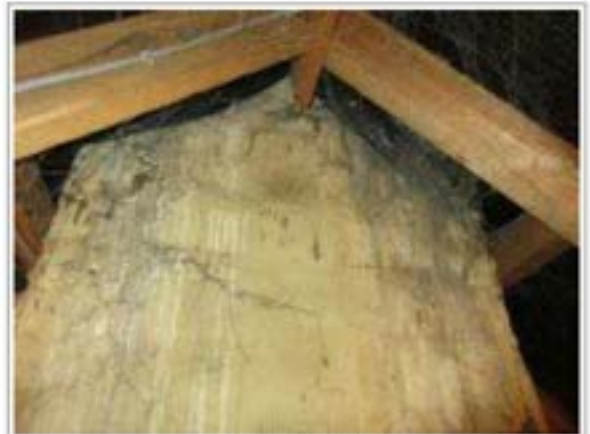
Stained chimney

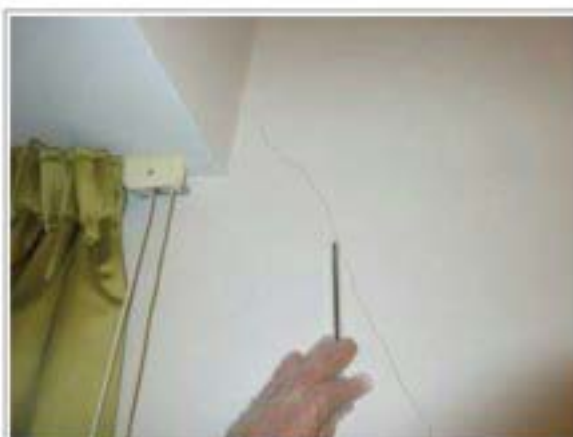
Crack to front bay

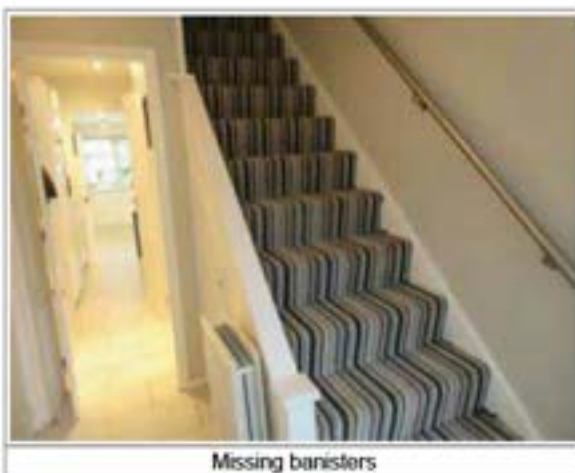
Missing banisters

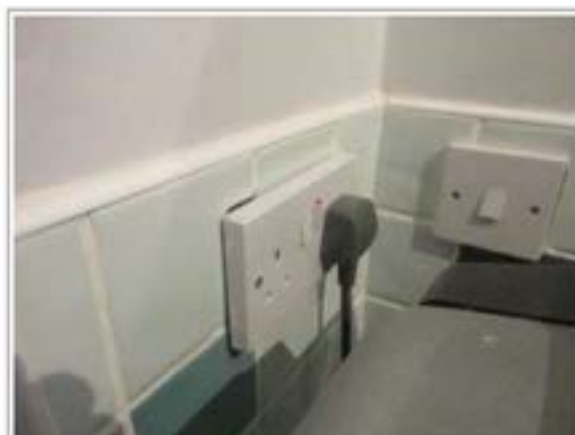
Loose socket

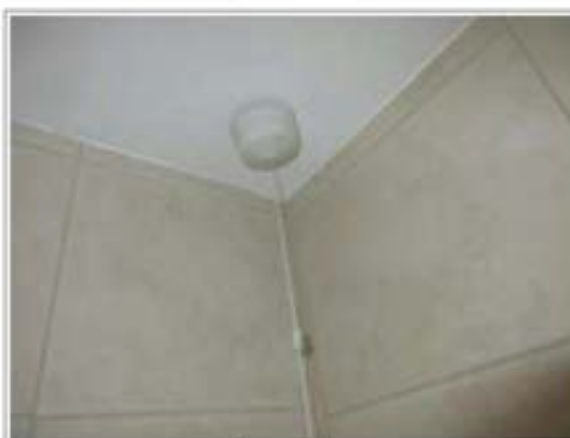
Loose fitting

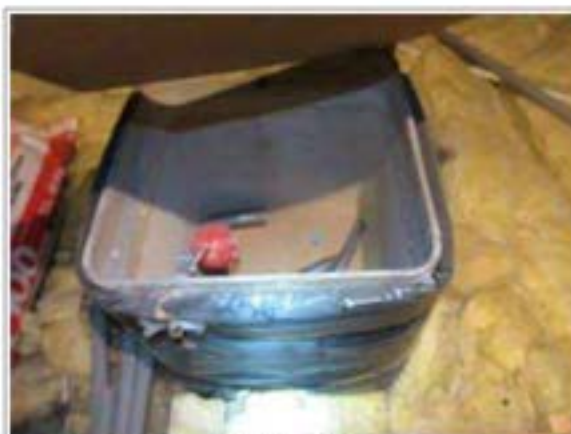
There is a redundant cold water storage tank located within the roof space. You may want to arrange for its removal. See our later comments under Section I3 - Risks to People regarding asbestos based materials.

Asbestos tank

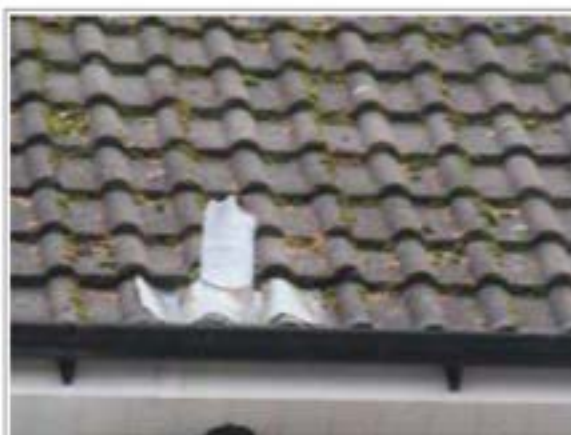
Missing vent pipe

We recommend that you obtain a quotation from a suitable contractor for the replacement of the soil pipe that should extend above the rear roof slope. See Section I - Risks.

It is recommended you arrange for a contractor to carry out a closer inspection of the pipe and where necessary, arrange for a new section to be built. You should arrange for quotations for this work as it may be relatively expensive as scaffold or some other access will be required that could increase the costs. (Please see Section I - Risks).

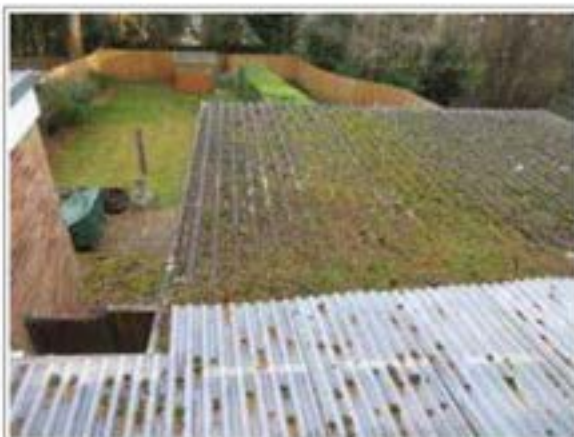
The roof has now reached the end of its serviceable life and you should budget for its early replacement. You should arrange for a suitable contractor to provide you with a quotation for such work as this may be costly. (Please see Section I - Risks).

Mossy garage roof

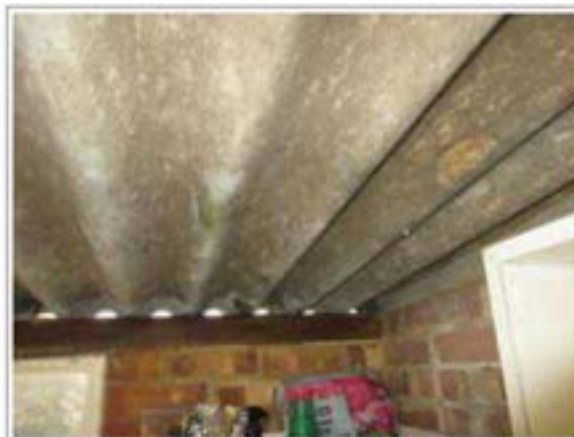
Flaking asbestos

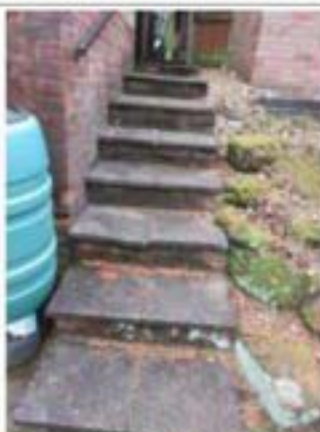
Loose slabs
