LEVEL 3

# Your survey report

Inspection date  
8th December 2021

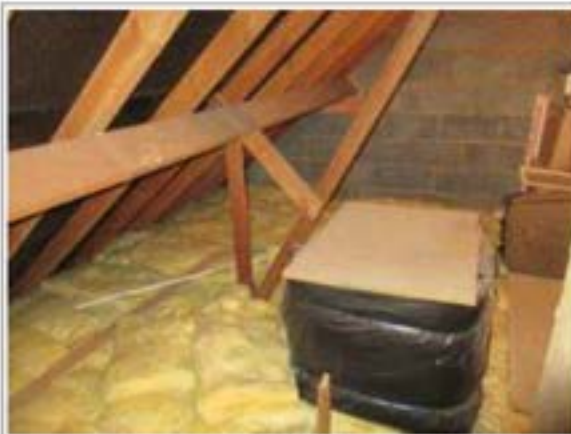
Main loft

A thick layer of insulation was noted throughout most of the roof void which is considered adequate by modern standards. A level of 300mm is recommended.

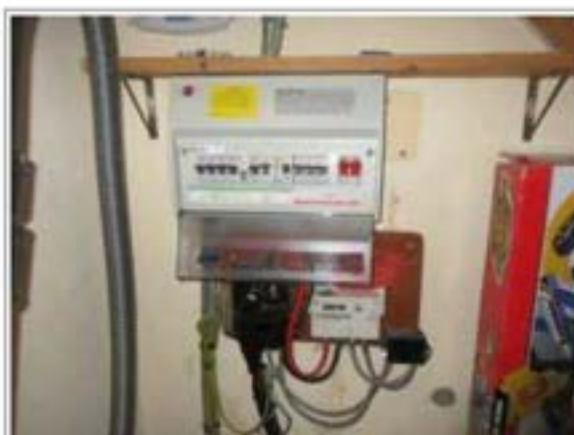
Consumer unit

Alterations are often undertaken to the electrical system which are then hidden from view. These may be a hazard especially when carried out by a property owner. Consequently, we would always recommend a test by a competent qualified electrician prior to exchange.

In addition to the above, if there is no record of an electrical test having been recently undertaken, it is recommended that the installation be tested by a competent electrician (NICEIC/ECA registered) prior to purchase so that you are aware of any likely future costs and all recommendations implemented. Thereafter, the installation should be retested every ten years. However, we would strongly recommend an inspection of the electrical system on change of ownership (Please see Section I - Risks).
